Manhole Inspection Summary

Manhole # S55I__027MH

Insp Date: **5/29/08 2:28 PM**

Location Address: **rear 3701 eastern ave**

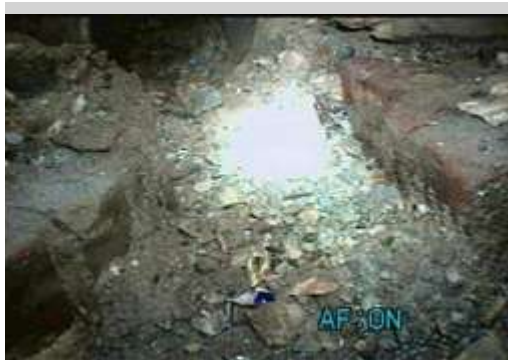
Defect 2

Condition: ☐ Sound ☐ Cracked ☐ Root Intrusion ☐ Deteriorated ☐ Leaks ☒ **Debris**

channel debris

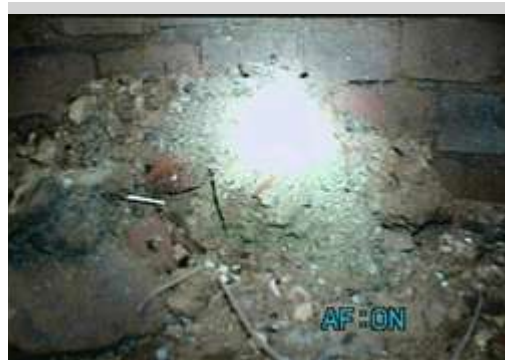
Defect 1

Condition: ☐ Sound ☐ Cracked ☐ Root Intrusion ☐ Deteriorated ☐ Leaks ☒ **Debris**

bench debris

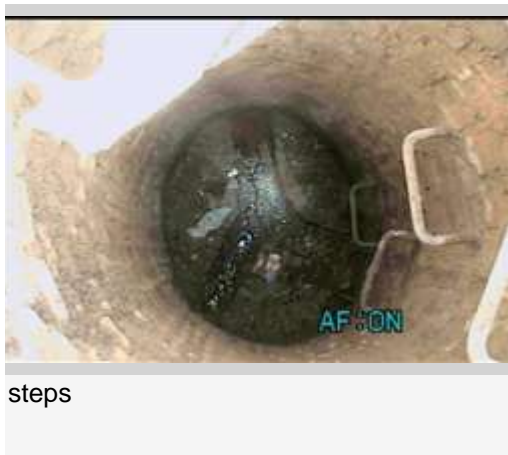
Defect 3

Steps Count: **5** Missing: **0** ☒ **Corroded**

steps

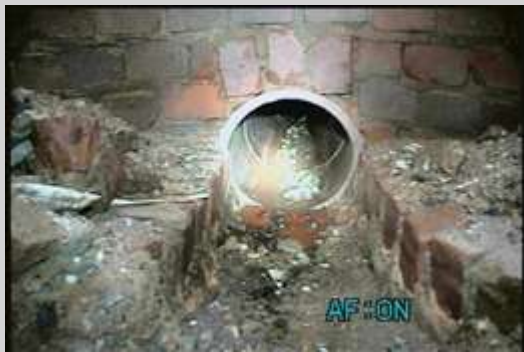
12 O'Clock Outflow

8 in. Circular Gravity Sewer
Pipe Out @ 12 O'Clock

Invert Depth: 11.15 (ft.) Flow Characteristics: **Fast**

Deposits: ☒ None ☐ Mud ☐ Sludge ☐ Debris ☐ Grease

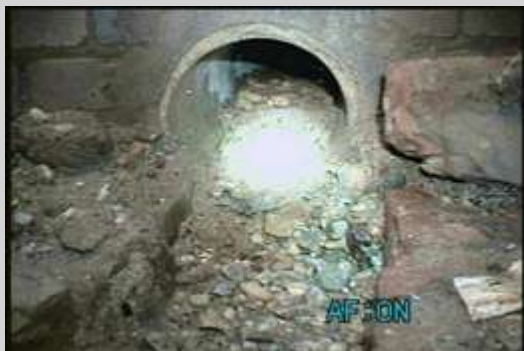
5 O'Clock Inflow

8 in. Circular Gravity Sewer
Pipe In @ 5 O'Clock

Invert Depth: 10.69 (ft.) Flow Characteristics: **Slow**

Deposits: ☐ None ☐ Mud ☐ Sludge ☒ **Debris** ☐ Grease

Silt Depth: 4 (in.) Deposits Extent: **Heavy**

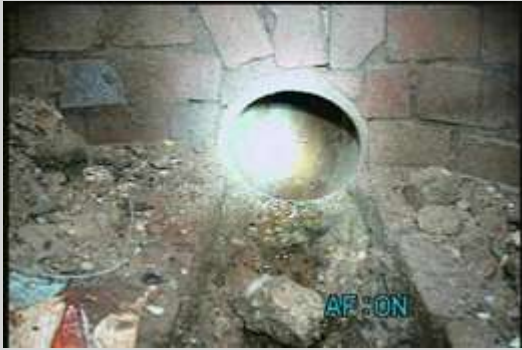
7 O'Clock Inflow

Pipe In @ 7 O'Clock

Invert Depth: 10.84 (ft.) Flow Characteristics: Fast

Deposits: ☒ None ☐ Mud ☐ Sludge ☐ Debris ☐ Grease
